Statement of Intent for the *Nunns road apartments*

MEMORANDUM

Subject: 1940 Nunns Road ESA Update

Date: April 13, 2023

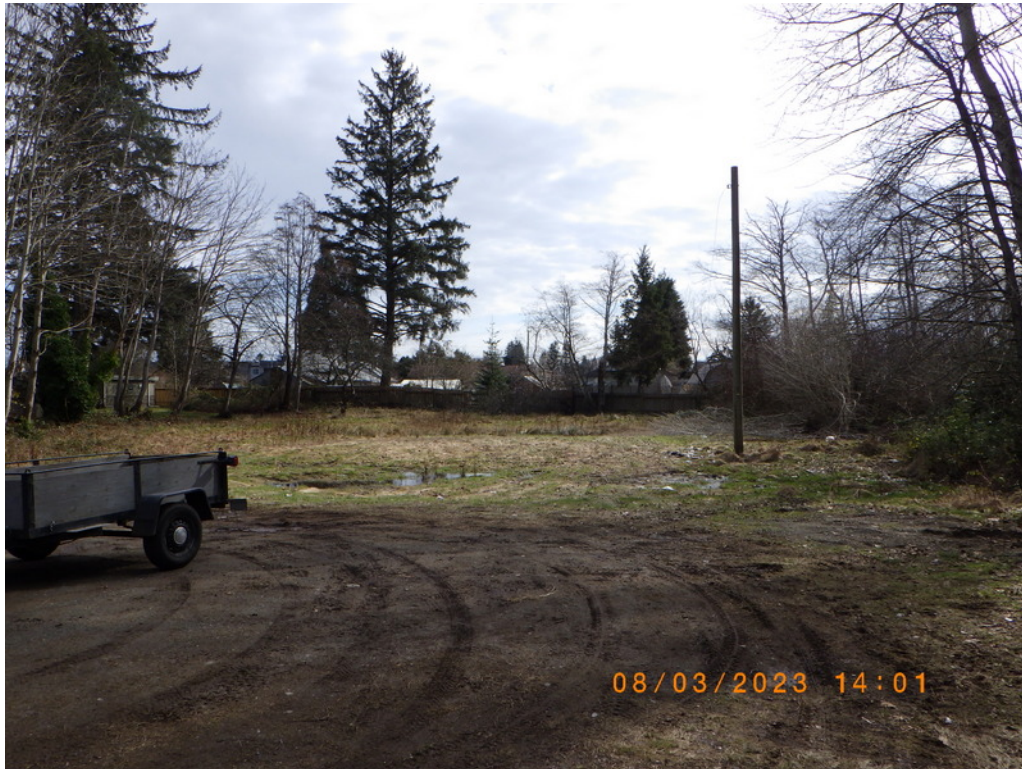
Photo 1

A view looking south over the clearing where the former house was removed at 1940 Nunns Road in March 2023.

At the time of the site assessment in March 2023, there were no buildings on the property (Photo 1). There was no major change in vegetation compared to the conditions described in 2021. The drainage features on the property were the same as described in the 2018 and 2021 ESA assessments. These features included a wetted area dominated by sedge on the south side of the property (Photo 2). This area drained to the north via a constructed ditch to a series of wetted pools along the western portion of the property (Photo 3). Overflow from these pools drained to the east through the vegetated depression in the middle of the property where it entered the previously documented ditch on the east side of the property (Photo 4). The ditch then flowed east

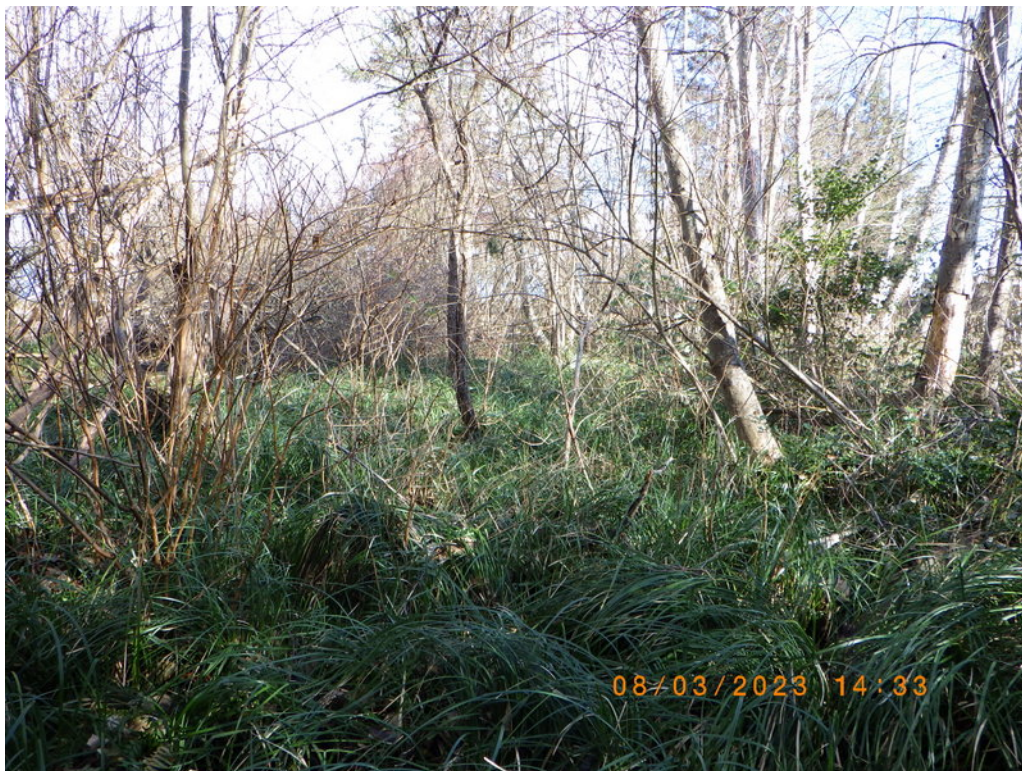
Photo 2

A view east looking through the wetted sedge area along the south side of the property.

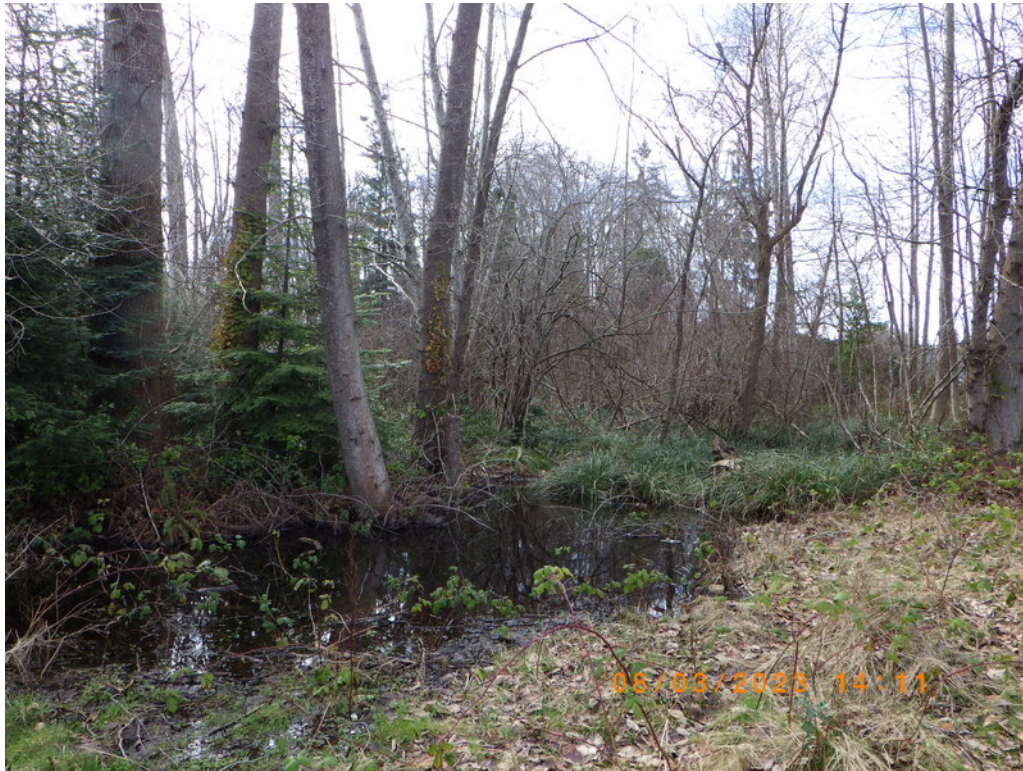
Photo 3

A view west looking at the pooled surface water present along the northwest portion of the property.

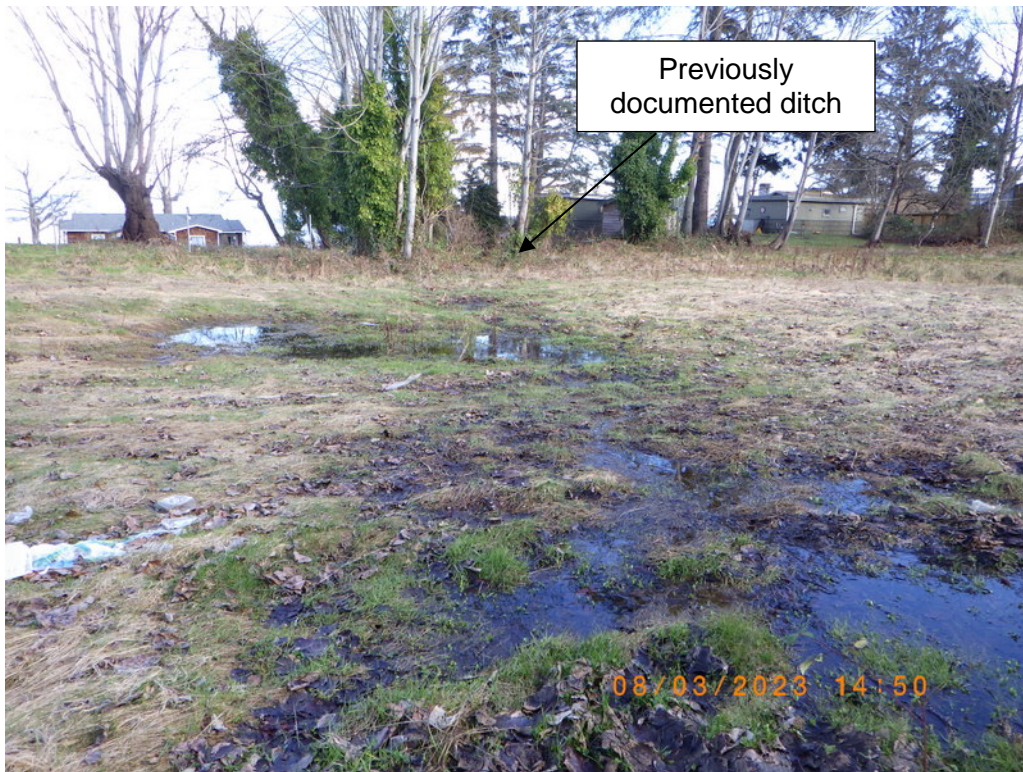
Photo 4

under the highway and discharged to the intertidal zone. The shallow pools on the west side of the property were determined to be seasonally wetted and not likely to offer quality breeding habitat for amphibian species. No new rare or sensitive wildlife or habitat features were documented during the March 2023 assessment.

A view east looking at the shallow, unconfined overflow from the shallow pools on the west side of the property through the vegetated depression flowing towards the ditch on the east side of the property.

If any open drainage remains on the property, a 2m vegetated setback (from top of ditch bank) is recommended to prevent erosion and protect downstream water quality in the marine environment. Once the drainages on the property have been culverted, the Streamside Protection and Erosion Areas (SPEA) that would have been established on them (2 m setback for a non-RAPR drainage) would no longer apply. The following section provides environmental protection measures that are to be applied during and following development to ensure the protection of water quality.
